PORT TOWNSEND

CHARLES PINK HOUSE
(JOHN BURNS HOUSE)

MITIGATION PLAN
FIREPLACE & CHIMNEY DOCUMENTATION

Published 24 January 2012

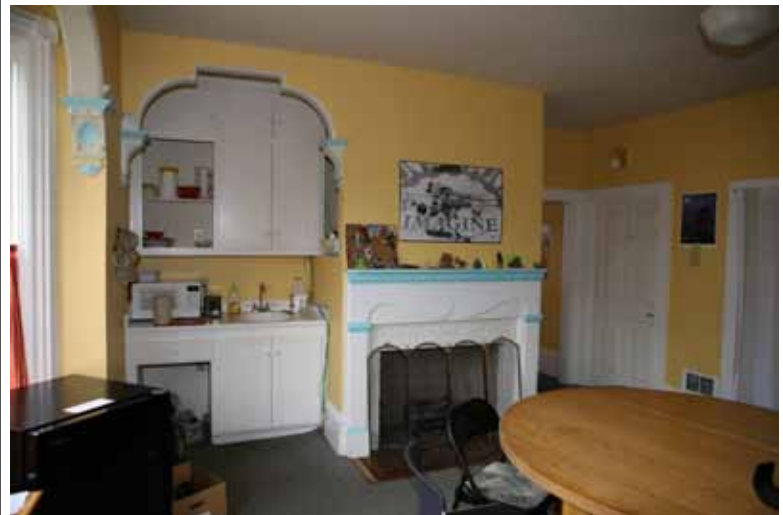
2: fireplace view looking west within the former kitchen space. Cabinets to the side of the fireplace were added in the 1990s in a former pantry/closet space. Plaster corbeling added during previous remodeling was retained and worked around.

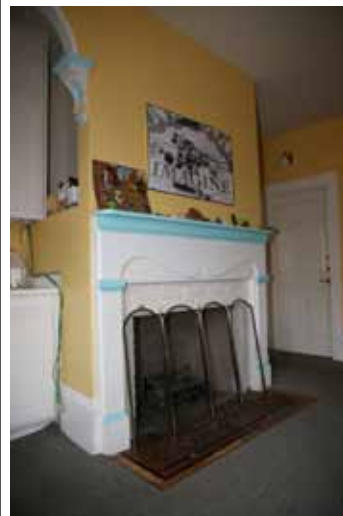
3: fireplace detail looking west. The cabinet in the side of the chimney, fire place screen, mantel, wood trim and sheetrock finish over the chimney breast above the mantel were added during the 1990s remodel.

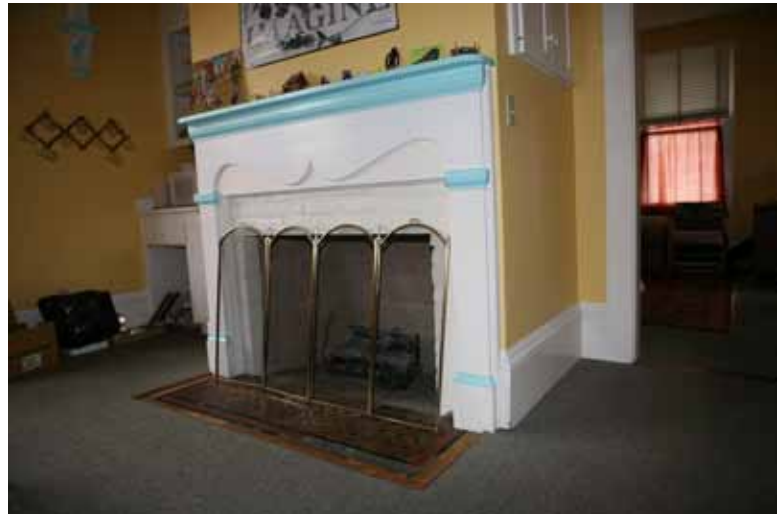
4: fireplace detail looking east. The fireplace was converted to propane and the firebox and inner hearth rebuilt with new brick and a faux-log insert added. Original mantel bricks were painted to match the new wood mantel coloring.

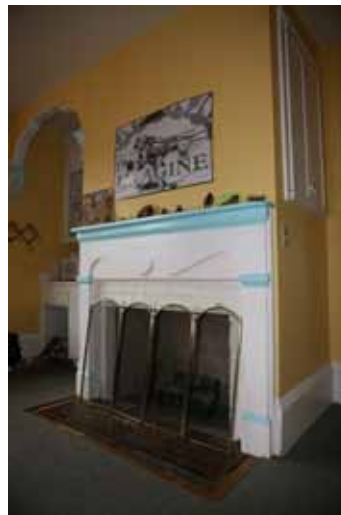
5: fireplace detail looking east. The cabinets in the side of the chimney were rebuilt as part of the 1990s remodel, along with new baseboard and painted sheetrock walls.

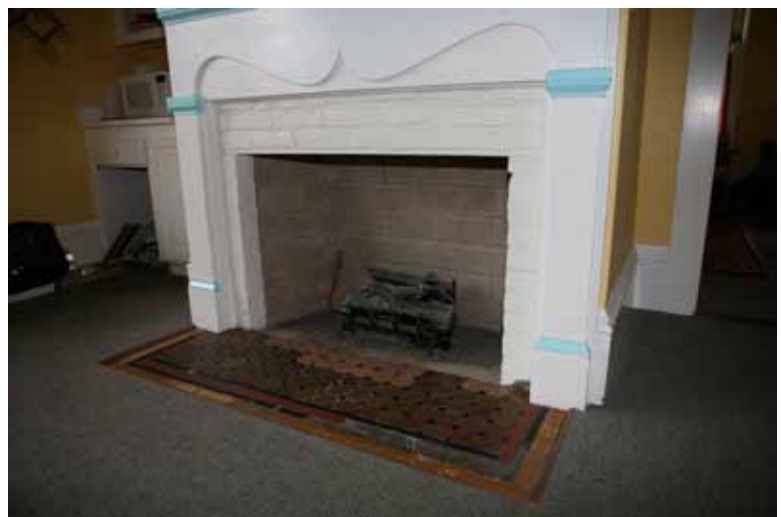
6: fireplace detail looking south. The lighter colored field tiles within the outer hearth are replacement tiles added during the 1990s to repair broken and missing original tiles. The remainder of the outer hearth tiles are original or early additions.

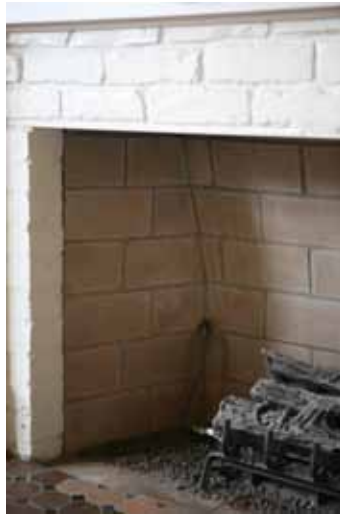
7: firebox detail looking east. Detail view of the new inner hearth and firebox brick and faux-log insert.

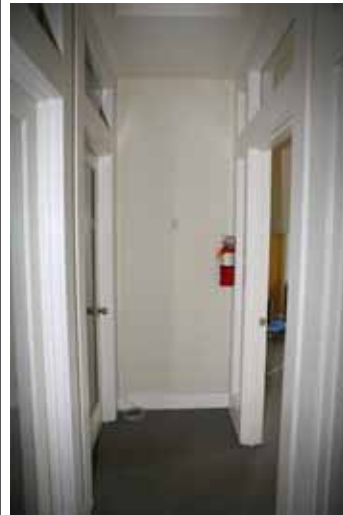
19: second floor hallway looking east with the chimney at the far end of the hallway. Hallway walls and finishes on the chimney are contemporary additions.

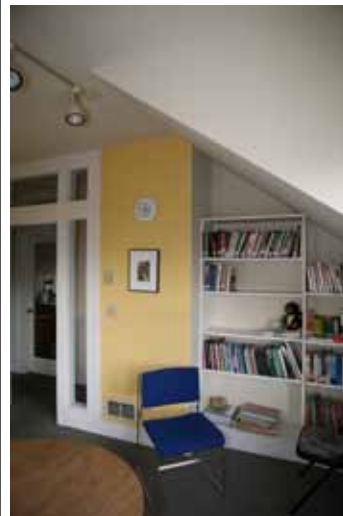
21: second floor southeast room looking northwest at the chimney (behind the yellow wall). Wall and ceilings all feature contemporary finishes over the brick chimney.

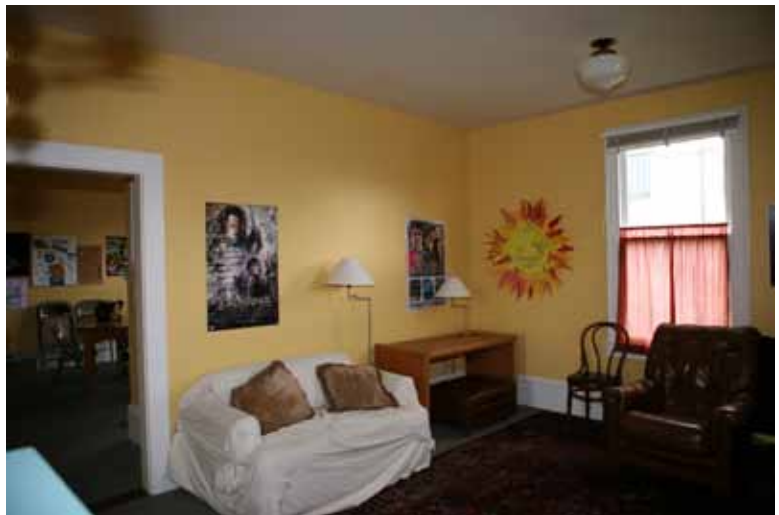
24: first floor southeast room looking northeast (baed on project north line) at the chimney. Originally the chimney served two fireplaces. The second provided heat to the living room. This fireplace used to be at the wall location behind the white sofa. The 1990s remodel extended the wall surface across this location removing this feature. It is not known if the 1990s work removed portions of the fireplace and hearth or encapsulated them in place.

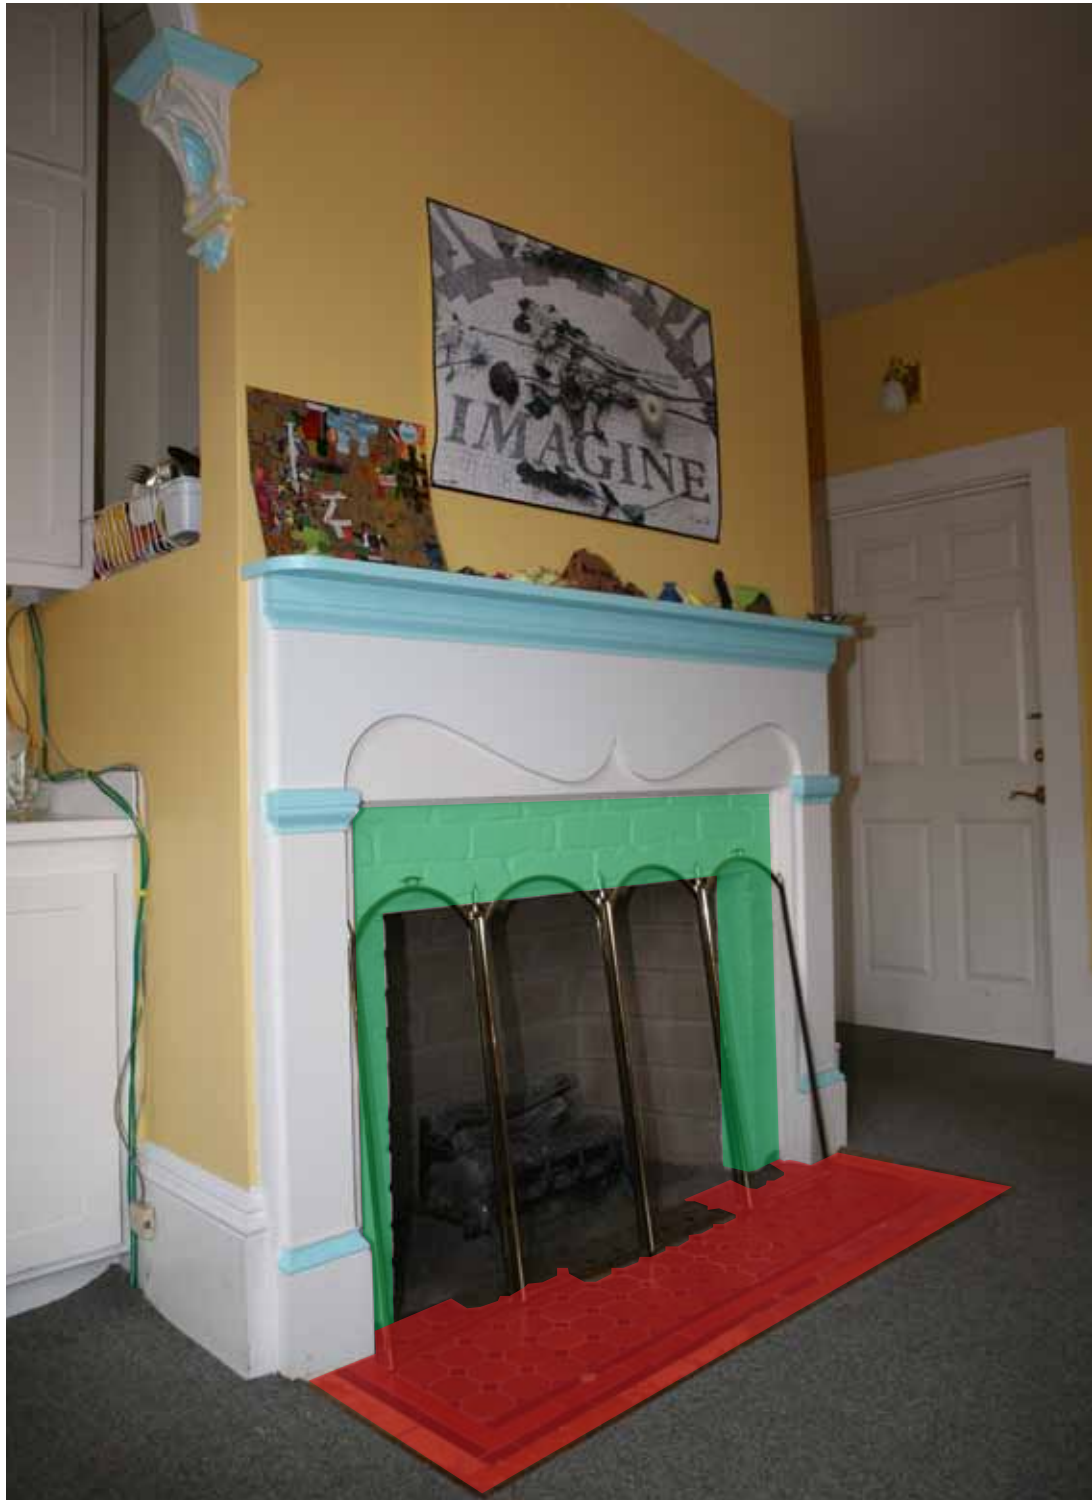
The following illustrates known visible interior original and contemporary materials pertaining to the fireplace. This represents the best information to date based on archival research and consultation with contractor(s) having previously worked on the building's interior. The living room side is not shown as no visible original materials remain.

Red indicates those intact original elements estimated to date to the early periods of alterations if not original construction of the house.

Green indicates those intact original elements that have been altered. In this case, the mantel brick that has been painted.

All other elements including the mantel, trim, wall finishes, and firebox brick are contemporary alterations.

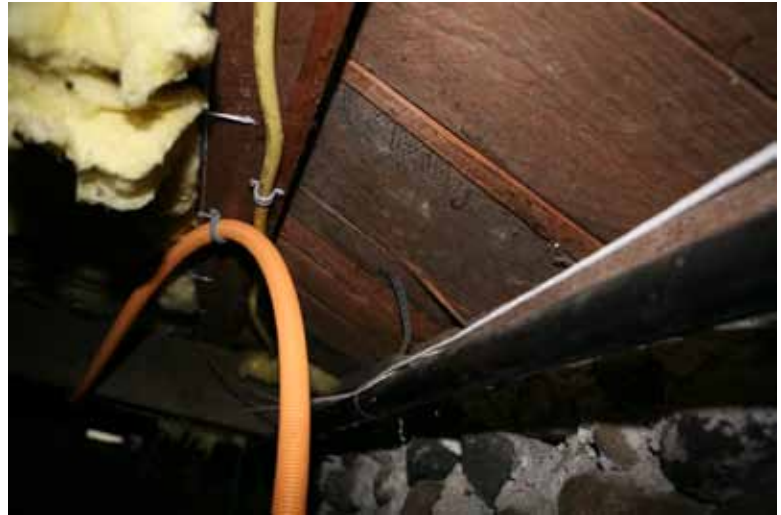
58: crawl space view of the boards supporting the hearth on the Lawrence Street side of the fireplace. View looking towards Harrison Street.
