May 7, 2024

**Re: Shoreline Geotechnical Assessment of Bulkhead Replacement Project**  
1010 57th Street and 1022 57th Street  
Port Townsend, Washington  
Project No. AS240151

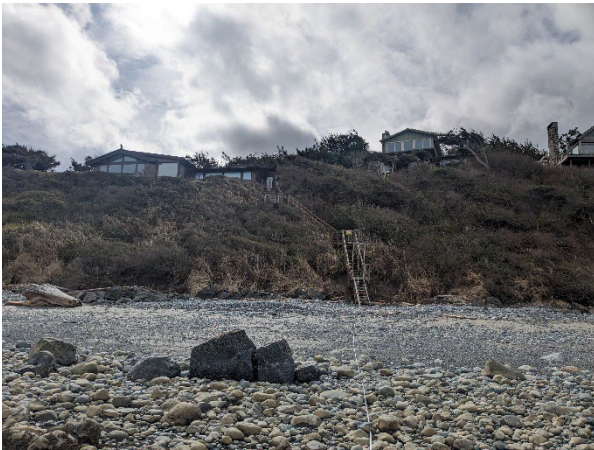
The Site is bordered by single-family residences to the west and south, an undeveloped parcel to the east, and the waters of the Puget Sound to the north (Photograph 1). The residences are accessed by separate gravel driveways extending north from 57th Street. Both Lots are connected to the City of Port Townsend (City) sewer system to the east. A continuous rock bulkhead spans the shoreline for the entire extent of both parcels and extends onto adjacent properties (Photograph 2). The date of bulkhead construction is unknown. Access to the beach is via a set of timber beach stairs shared by both residences.

**Photograph 1.** View of the bulkhead and residences from the shoreline, view to the southwest.

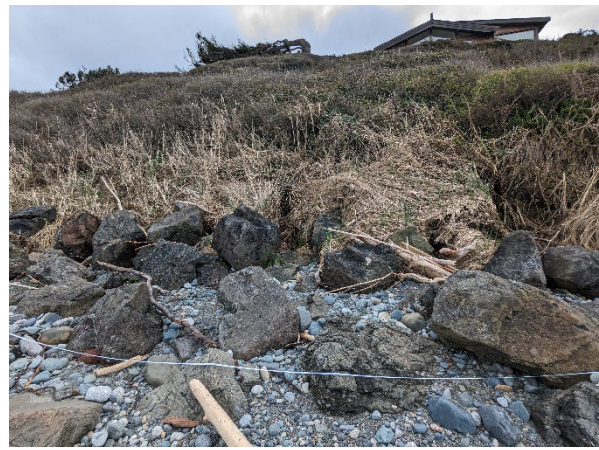
**Photograph 2.** Bulkhead along the shoreline north of the residences, view to the south.

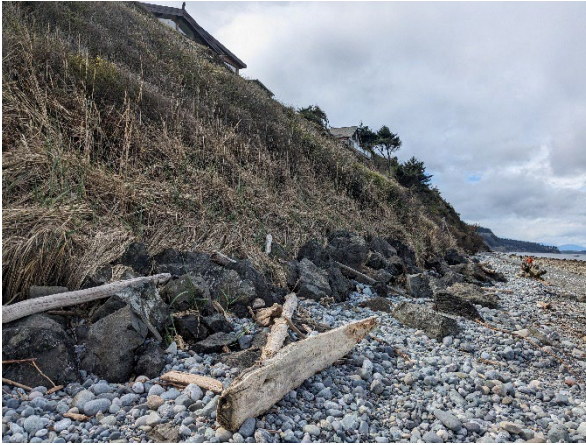
The West Lot consists of a 0.35-acre, roughly rectangular parcel that spans about 305 to 322 feet north-to-south and about 50 feet east-to-west. The West Lot is developed with a three-story, 2,506-square-foot residence with a 572-square-foot attached garage built in 2006 (County, 2024). The 1,298 square-foot residence foundation footprint was measured 15 feet landward of the top of the steep shoreline slope at its closest point. A set of timber stairs provides access to the shoreline just north of the residence (Photograph 3).

**Photograph 3.** Steep shoreline slope from the residences to the shoreline, view to the west.

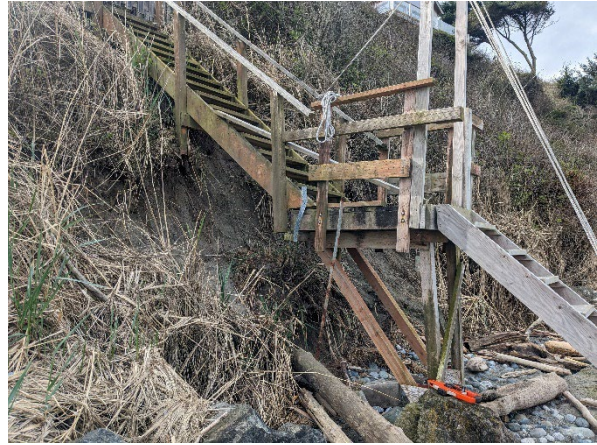
The ground surface from 57th Street to the residences slopes slightly down to the east-northeast with about 17 feet of elevation loss over about 180 feet for an average inclination of 9 percent, 5 degrees (County, 2024). North of the residences, the ground surface slopes steeply down to the north-northwest towards the shoreline with about 44 feet of elevation loss over 65 feet for an average inclination of 68 percent, 34 degrees, at the west end of the Site and 32 feet of elevation loss over about 50 feet for an average inclination of 64 percent, 32.5 degrees, at the east end. Areas of locally steeper slopes are present near the top and base of the steep shoreline slope. In general, the slope becomes steeper and taller from the south-southeast to the north-northwest. Near the base of the timber beach stairs, we observed up to 15 feet of near-vertical, exposed sand (Photograph 4).

**Photograph 4.** Erosion observed at toe of steep shoreline slope under existing beach stairs, view to the southwest.

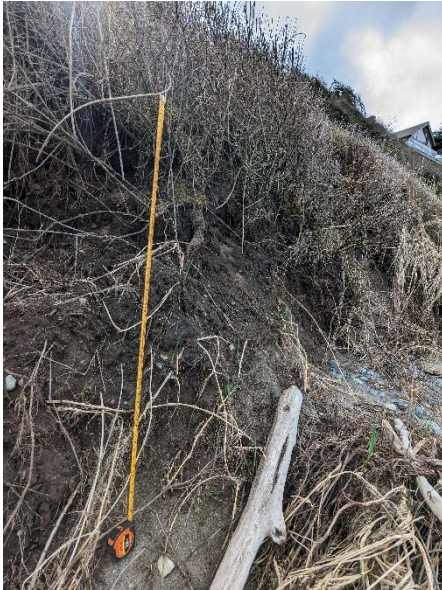
An existing rock bulkhead spans the entire toe of the steep shoreline slope, which is about 150 feet in length at the Site. The construction date of the bulkhead is not known; however, based on our records review it has been present since at least July 12, 1994 (Photograph 5; Google, 2024; NETR, 2024; Ecology, 2024). The bulkhead consists of 1- to 5-foot-diameter rocks stacked up to 4 feet tall above the shoreline with no fill or filter fabric present behind. We observed bulkhead rocks almost fully embedded in the beach face material. The bulkhead has been damaged over time by wave and tidal erosion. In many places along the length of the Site, we observed gaps of up to 10 feet between armor rocks. In areas where the rock bulkhead was damaged or missing, we observed localized erosion and retreat of the slope toe (Photograph 6).

**Photograph 6.** Erosion behind area of missing face rocks, view to the southwest.

The existing rockery bulkhead at the Site is in poor condition and no longer functioning as intended. The rockery has been damaged by wave and tidal action. Gaps up to 10 feet wide were observed where rocks had been washed out from the base of the bulkhead and/or fully buried in the beach face. Where waves can directly impact the bluff, we observed erosion and landward retreat of up to 7 feet creating a 10- to 12-foot-tall vertical scarp of loose sand. If damage were to continue, the steep shoreline slope—and ultimately the residences—would be at risk. Replacement of the bulkhead with a gravity rock bulkhead will provide effective shore protection at the Site and long-term protection for the residences.

This is the chosen alternative for this Site. Alternative vii calls for a hard bulkhead located just inside, or landward of, the existing bulkhead. In our opinion, a new rock revetment can be feasibly constructed 3 to 5 feet landward of the existing bulkhead and the existing bulkhead removed. The armor replacement will extend 150 feet from property line to property line.

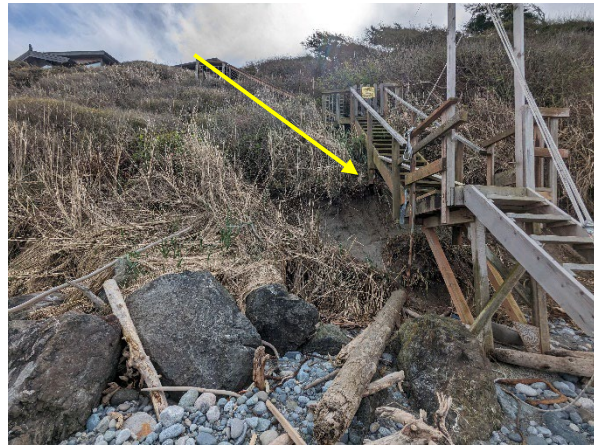
Access to the beach is provided by a set of timber beach stairs between the two residences. The base of the stairs has been undermined as the bluff face has retreated landward. We observed that the timber stair support beams were unsupported and just hanging in the air about 10 feet above the beach surface (Photograph 7). Near the stairs, we observed erosion of the slope for another 2 feet upslope of the unsupported beams. In the vicinity of the stairs, for a total length of about 20 feet, the slope has retreated up to 7 feet landward relative to the surrounding toe. We understand that much of this erosion has occurred since January 2024 (Vanselow, 2024).

**Photograph 7.** Erosion under beach stairs, yellow arrow pointing to unsupported posts, view to the south.

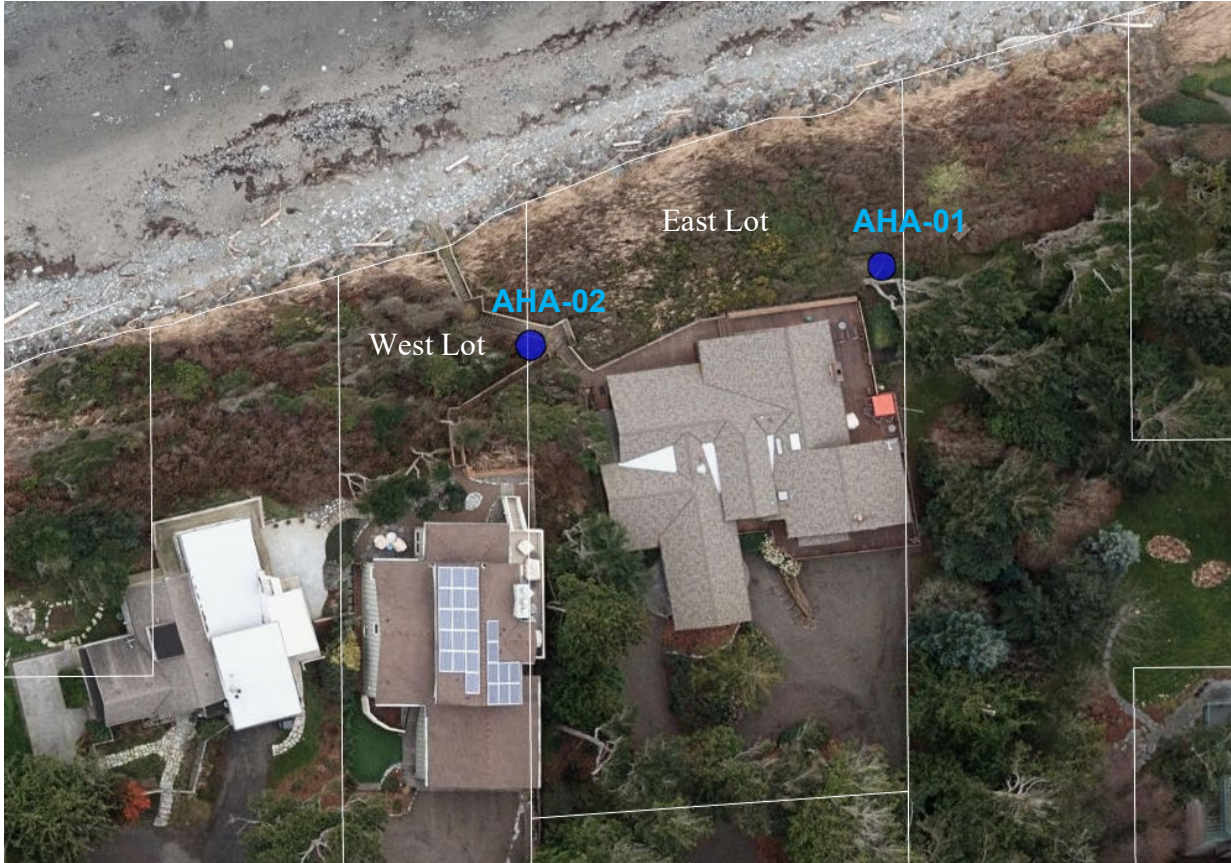
We advanced two shallow hand explorations, AHA-01 and AHA-02, to 2.1 and 4 feet below the ground surface (bgs), respectively (Figure 1). In AHA-01, located near the top edge of the bluff east of the East Lot residence, we encountered about 0.75 feet of topsoil underlain by brown, moist sand with silt (SP-SM) and few rounded cobbles to 2.1 feet bgs, which we interpreted to be topsoil. In AHA-02, about 8 feet down the slope between the residences, we encountered very loose to loose, brown sand with trace gravel from the surface extending to 2 feet bgs. We interpreted this material to be weathered recessional outwash or colluvium. This was underlain from 2 feet to 4 feet bgs by loose, gray brown, medium to coarse sand which we interpreted to be recessional outwash.

**Figure 1.** Locations of hand explorations AHA-01 and AHA-02 at Site (Google, 2024).

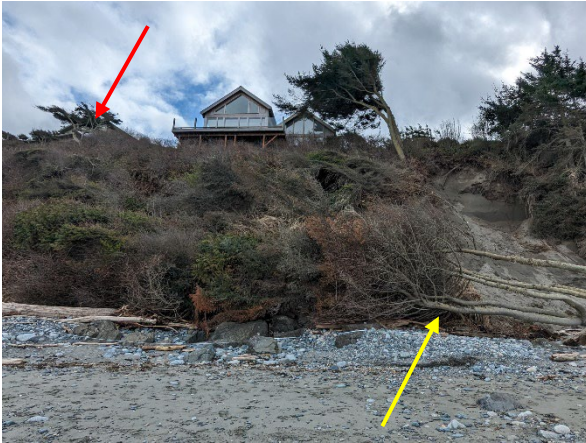
During our reconnaissance, we did observe a surficial landslide directly on the western adjacent property, west of the end of the bulkhead about 50 feet west of the Site’s west property line. We also observed disturbed vegetation and exposed soils in the landslide area in imagery from 2009 to 2023. We understand that a large spruce (at least 65 feet tall) slid from near the top of the shoreline slope to the shoreline in early 2024 (Vanselow, 2024). We did not observe any evidence of deep-seated rotational slides or topples at or nearby to the Site.

**Photograph 8.** Yellow line points to end of bulkhead on west-adjacent property at the start of the landslide and red arrow points to residence on West Lot, view to the south.

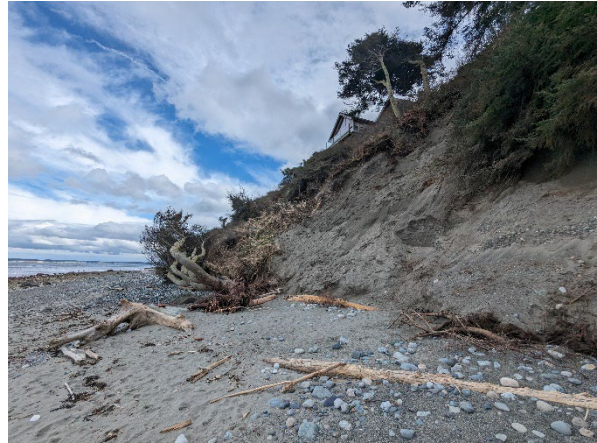
**Photograph 9.** Landslide on adjacent property, about 50 feet west of Site, view to the east.

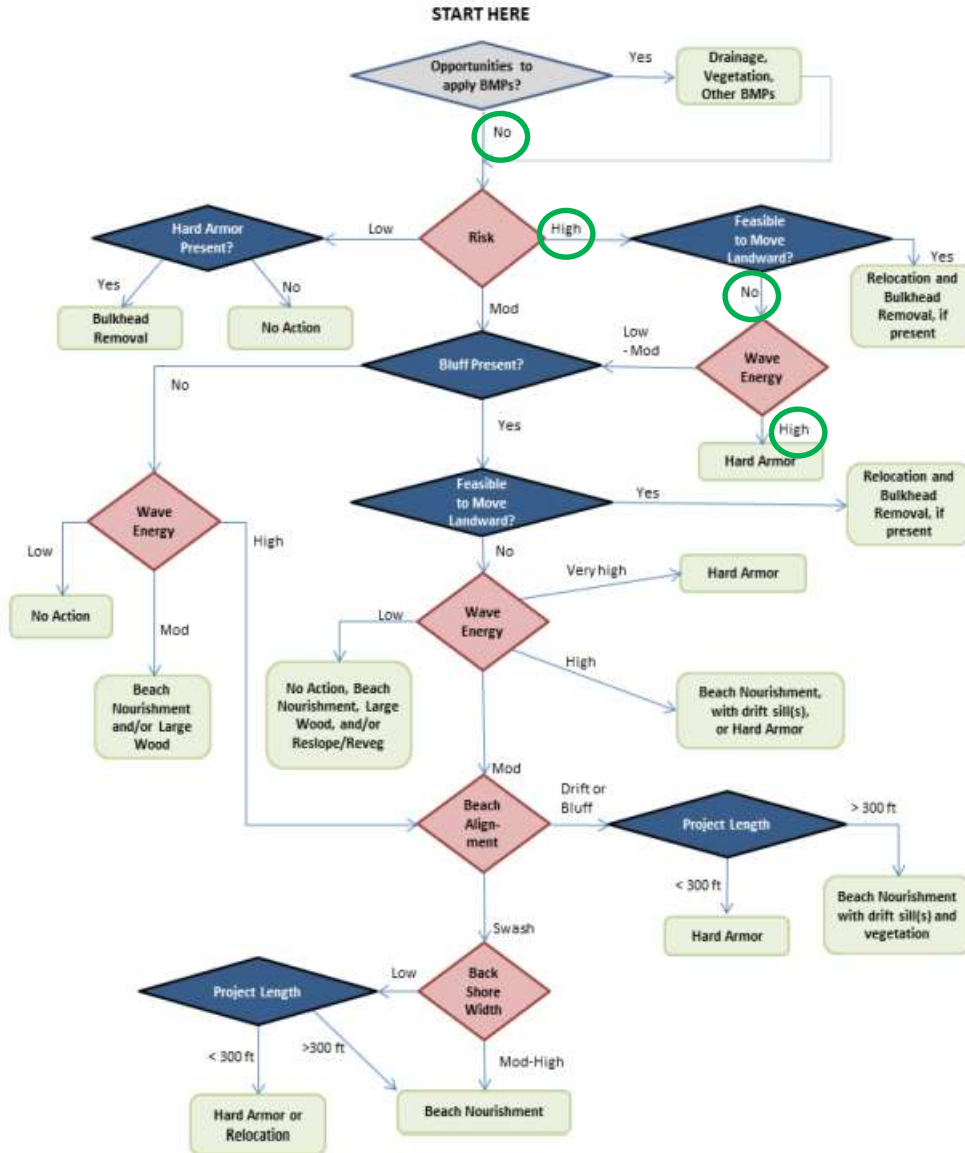
Figure 3. Decision Tree (excerpt from Johannessen et al., 2014).

Using the decision tree, hard armor is appropriate at the Site under high risk conditions, as determined by the Cumulative Risk Model (selections circled in green on Figure 3).
