PORT TOWNSEND

CHARLES PINK HOUSE
(JOHN BURNS HOUSE)

MITIGATION PLAN
FIREPLACE & CHIMNEY DOCUMENTATION

Published 24 January 2012

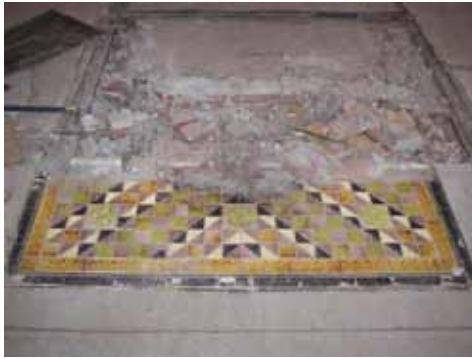
Hearth tiles previously covered.
2011
