May 7, 2024

**Re: Shoreline Geotechnical Assessment of Bulkhead Replacement Project**  
1010 57th Street and 1022 57th Street  
Port Townsend, Washington  
Project No. AS240151

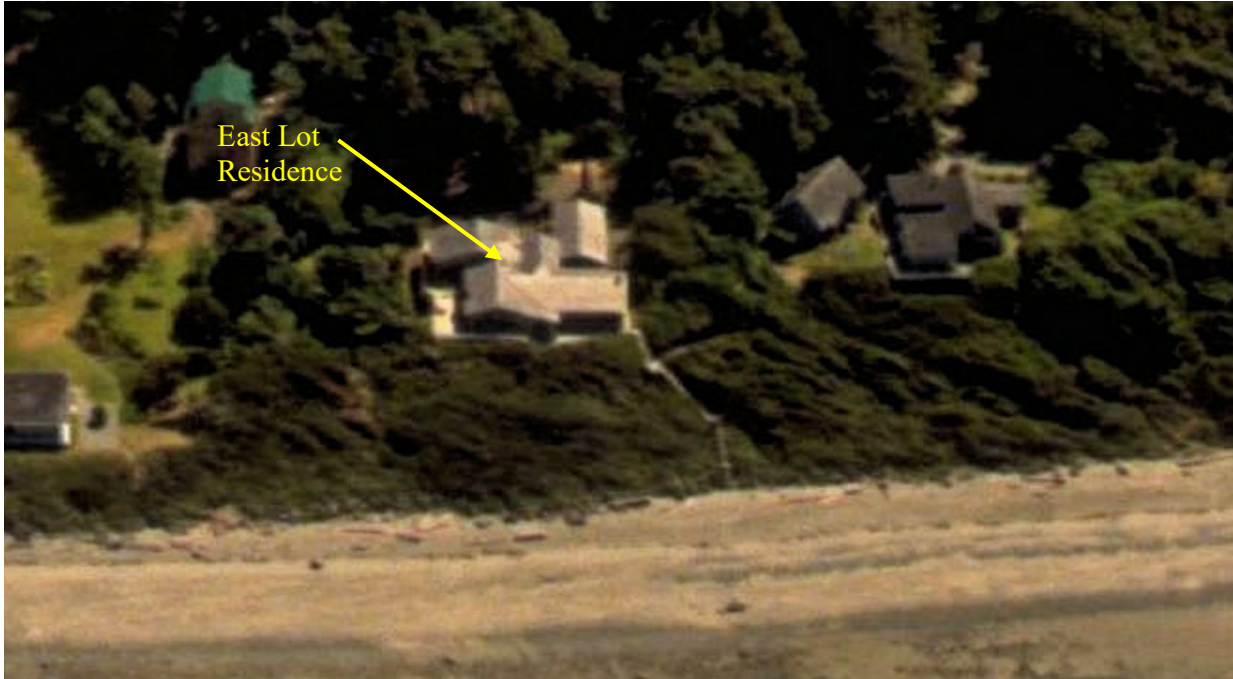
**Photograph 5.** Coastal Oblique Aerial Photograph taken July 12, 1994 (Ecology, 2024)

An existing rock bulkhead spans the entire toe of the steep shoreline slope, which is about 150 feet in length at the Site. The construction date of the bulkhead is not known; however, based on our records review it has been present since at least July 12, 1994 (Photograph 5; Google, 2024; NETR, 2024; Ecology, 2024). The bulkhead consists of 1- to 5-foot-diameter rocks stacked up to 4 feet tall above the shoreline with no fill or filter fabric present behind. We observed bulkhead rocks almost fully embedded in the beach face material. The bulkhead has been damaged over time by wave and tidal erosion. In many places along the length of the Site, we observed gaps of up to 10 feet between armor rocks. In areas where the rock bulkhead was damaged or missing, we observed localized erosion and retreat of the slope toe (Photograph 6).
