Wetland Investigation and Delineation Report

Boat Haven Infrastructure and Maintenance Projects

Port of Port Townsend Jefferson County, Washington

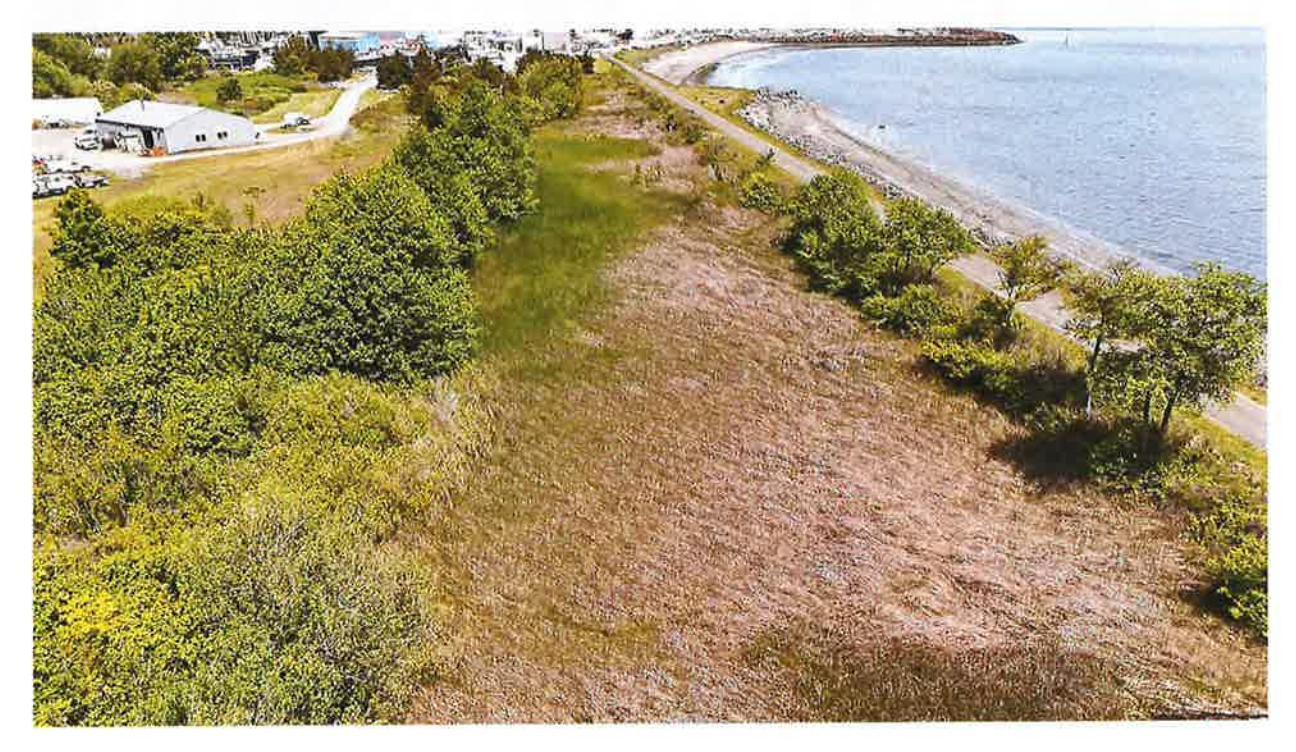
Photo 1. Aerial view of the Study Area, facing north. The Study Area is confined by 8th Street (left), the Boatyard (center back), and the Larry Scott Trail (right). Port Townsend Bay can be seen in the background.

The study area encompasses approximately 6.95 acres of existing wetlands, uplands, and stormwater facilities constrained by roads on the northwest, west, and south; the Larry Scott Memorial Trail to the southeast; and the existing Boatyard to the northeast (Photo 1). The roads and trails bordering the study area are regularly mowed and maintained by the Port of Port Townsend and volunteers from the Peninsula Trails Coalition.

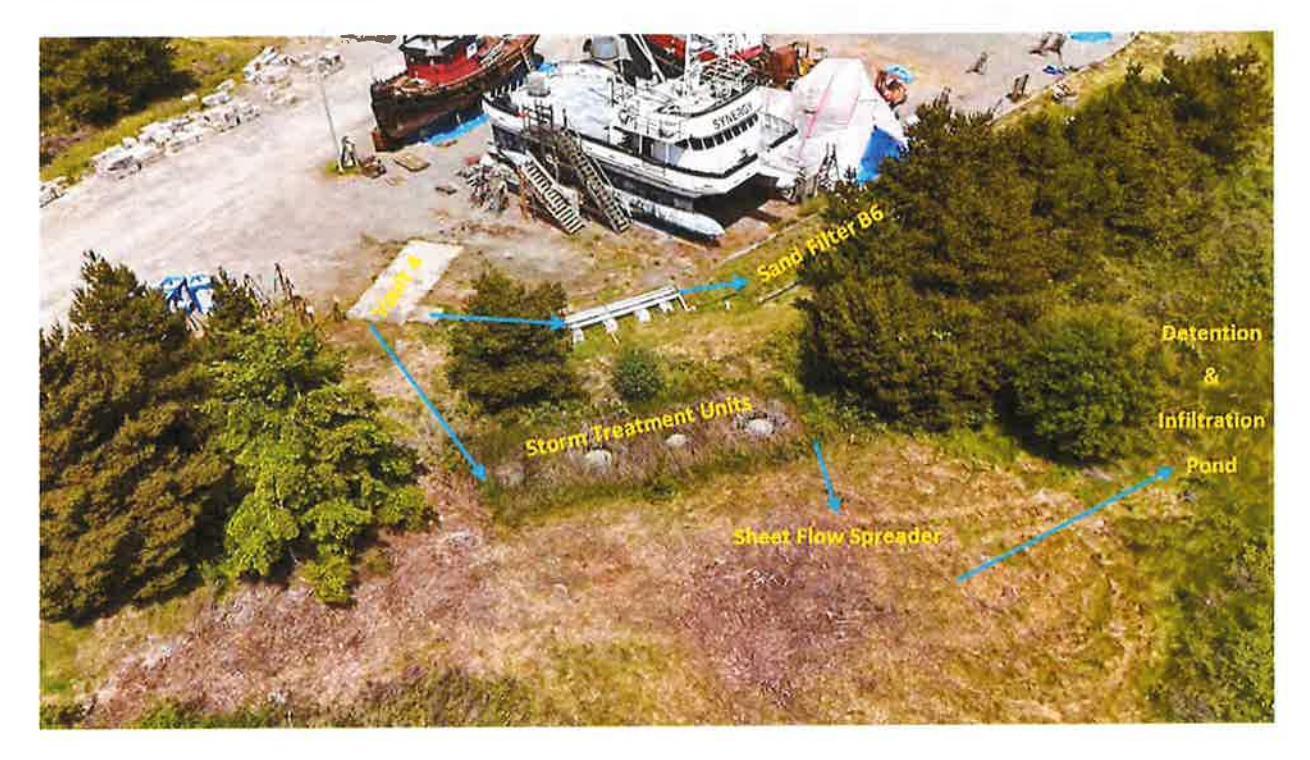
Photo 3. The existing Port Stormwater Facility (center) is located at the northern margin of the study area, adjacent to the Boatyard. Stormwater from the facility discharges to the depression (far right) for detention and infiltration, as evidenced by the green vegetation. The wetland buffer ends at the southern edge of development as the Boatyard and Port Stormwater Facility effectively preclude the function and value typically derived from wetland buffers.

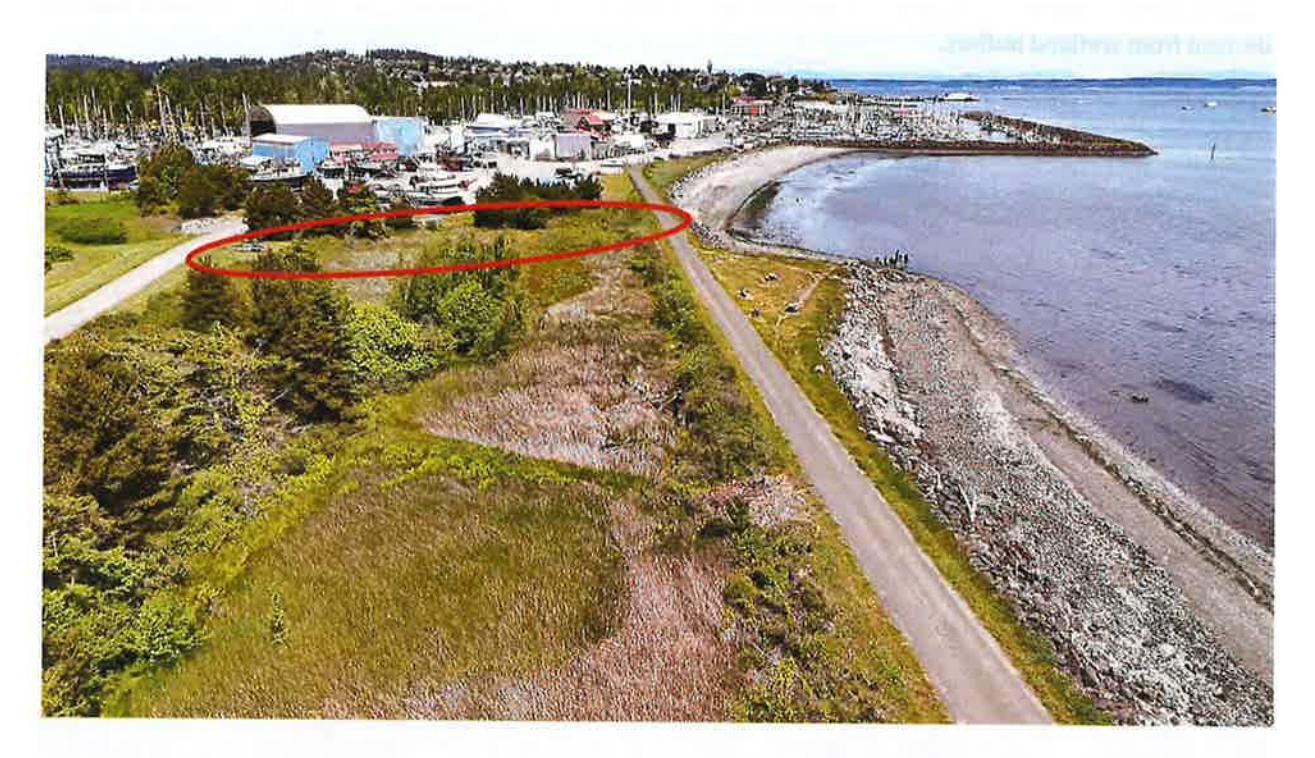
Photo 4. Study area facing north. The flow spreader embankment (circled in red) stretches from 8th Street to the Larry Scott Memorial Trail, separates Wetland A from the Boatyard. The Study Area is confined by 8th Street (left) and the Larry Scott Trail (right).

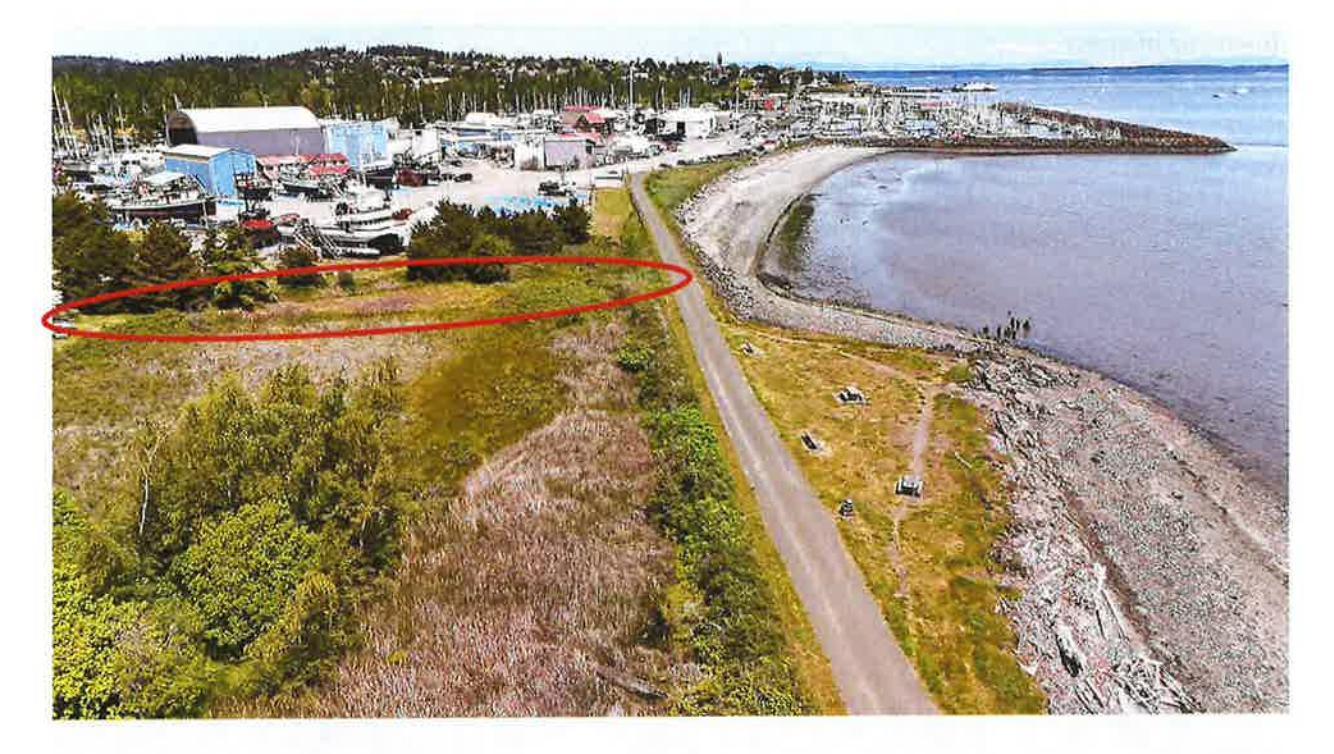
Photo 5. Study area facing north. The flow spreader embankment (circled in red) stretches from 8th Street to the Larry Scott Memorial Trail, separates Wetland A from the Boatyard. The Study Area is confined by 8th Street (left) and the Larry Scott Trail (right).

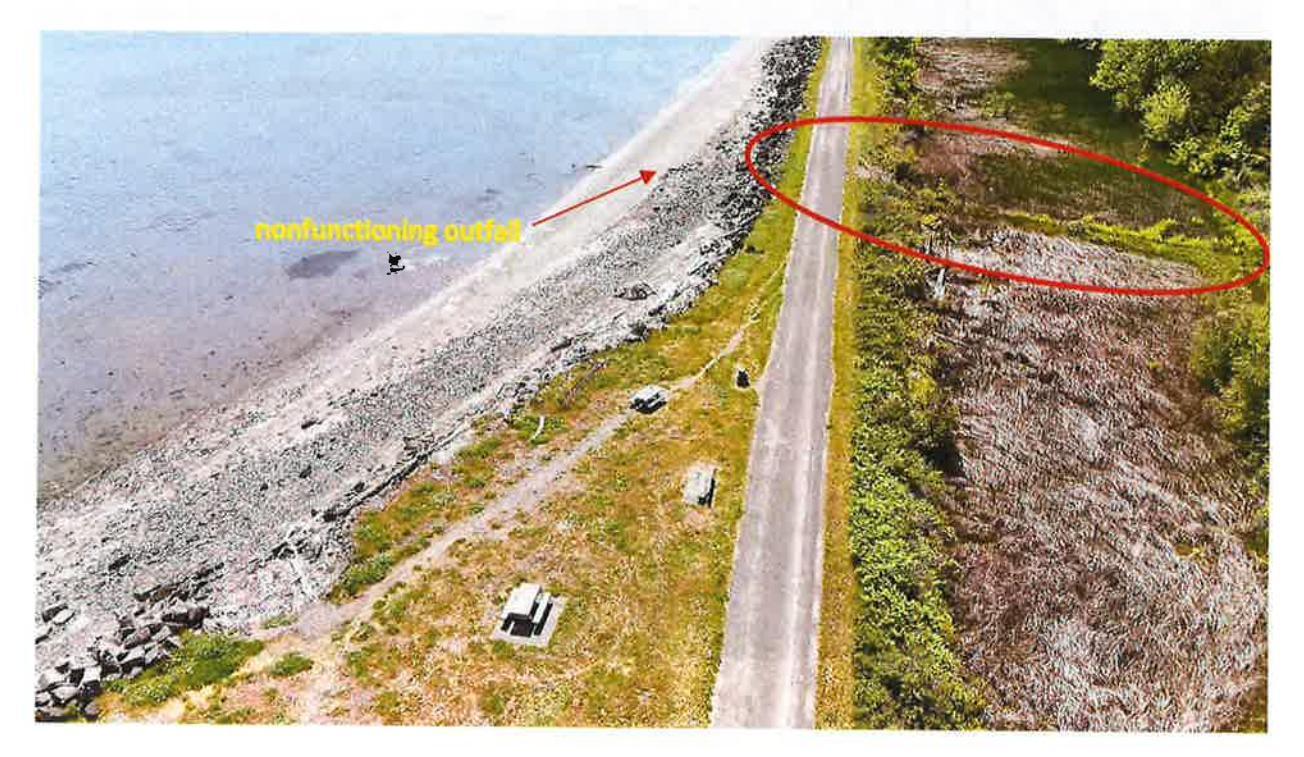
Photo 6. Facing south. Wetland A (right) is bifurcated by an inoperable City stormwater drainpipe (circled in red) which used to outfall (arrow) below the HTL of Port Townsend Bay. The inoperable City pipe prevents stormwater runoff from SR-20/Sims Way and City sub-basin 10a from discharging to Port Townsend Bay as intended. As a result, the City stormwater provides poor quality hydrologic inputs to Wetland A on Port of Port Townsend property.

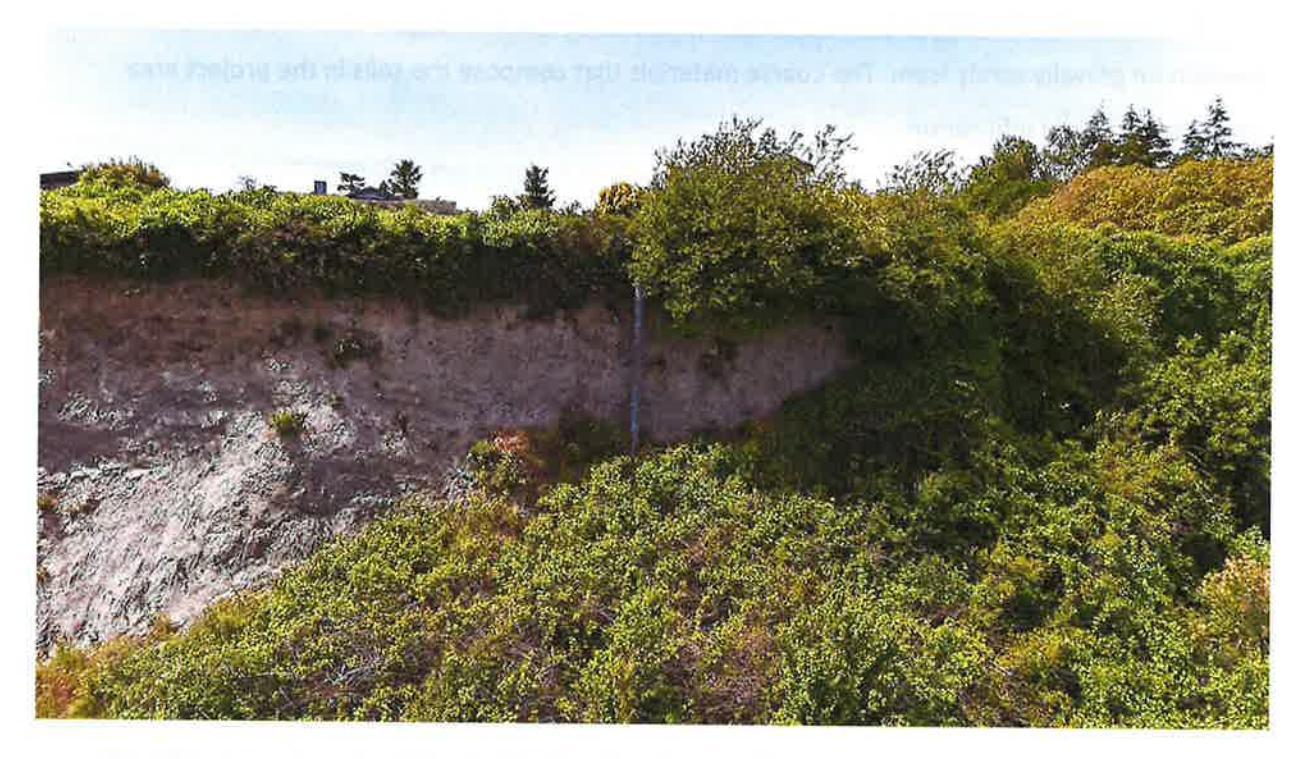
Photo 7. Feeder bluff to the southwest of the project area, looking west. A drainage pipe on the side of the bluff conveys untreated stormwater runoff originating in a City residential neighborhood to Wetland A on Port property.

In addition to the small quantity of precipitation, the Study Area receives hydrologic inputs from poor quality stormwater runoff originating in SR-20/Sims Way, City sub-basin 10a, and a City residential neighborhood on the feeder bluff to the southwest (Photo 7). Salt spray during high tides twice daily selectively influences the vegetative communities in the project area for those that can tolerate saline environments. It is also suspected that saltwater intrusion occurs through the coarse trail embankment and groundwater upwelling at high tides, however, further investigation is required to determine if this is the case.

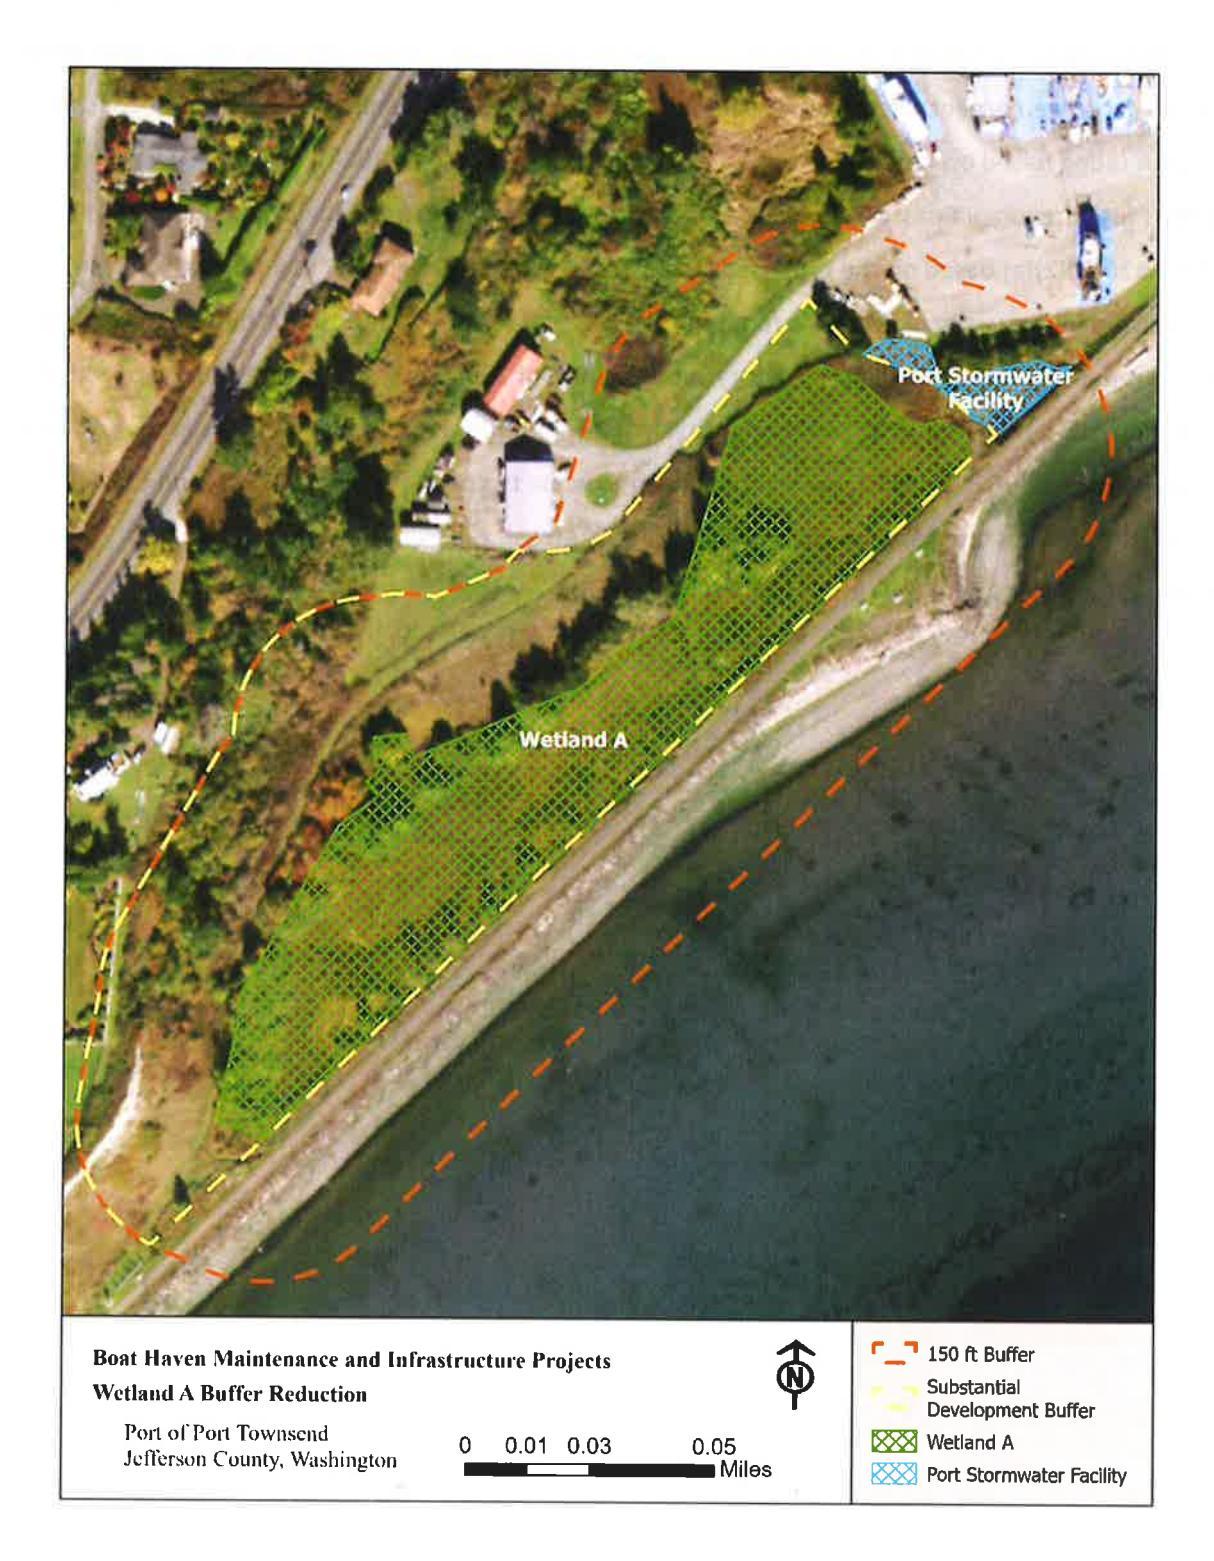
Figure 3. Wetland A buffer (yellow). The 150-foot Category II, high-intensity land use wetland buffer (orange) is truncated at the boundary of substantial development that precludes the functions and values typically provided by wetland buffers.

The investigation resulted in the identification of one wetland, Wetland A. Wetland A was determined to be a largely emergent depressional wetland meeting the requirements for a Category II Coastal Lagoon rating based on functions and special characteristics (Ecology, 2024) (Appendix G). Buffer widths for Category II Coastal Lagoons are prescribed by Port Townsend Municipal Code 19.05.110(G)(2)(a) based on the proposed land use of the development; for low-impact land use intensity, a buffer width of 75 feet is required; for moderate land use intensity, a buffer width of 110 feet is required; for high land use intensity, a buffer with of 150 feet is required. As Boatyard activities typically have a high-impact land use intensity, a 150-foot buffer is assumed to be required. However, substantial development precludes the function and value typically derived from wetland buffers. As a result, the buffer is truncated at the boundaries of 8th Street, the existing Boatyard, the Port Stormwater Facility, and the Larry Scott Trail (Figure 3).
