PORT TOWNSEND

CHARLES PINK HOUSE
(JOHN BURNS HOUSE)

MITIGATION PLAN
FIREPLACE & CHIMNEY DOCUMENTATION

Published 24 January 2012

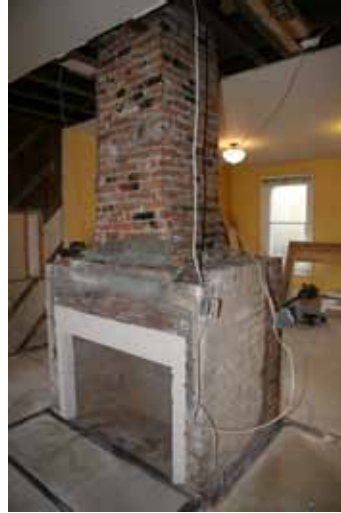
56: first floor view of the chimney looking toward the library.

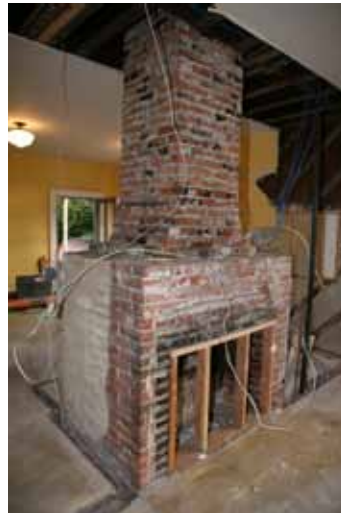
57: first floor view of the chimney stack looking toward the library.

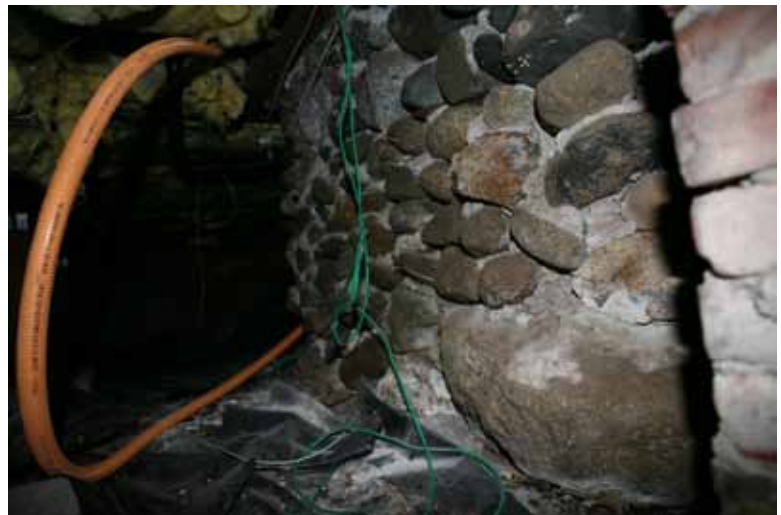
60: crawl space view of the stone fireplace. View looking towards the back parking lot.

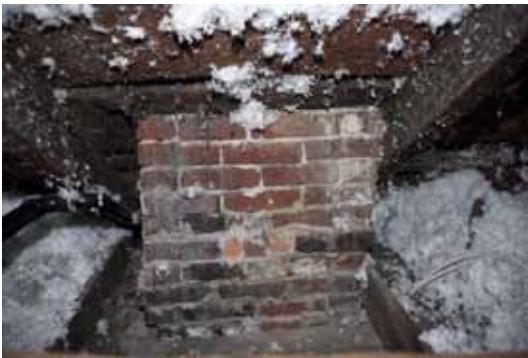
Chimney in attic.
2011

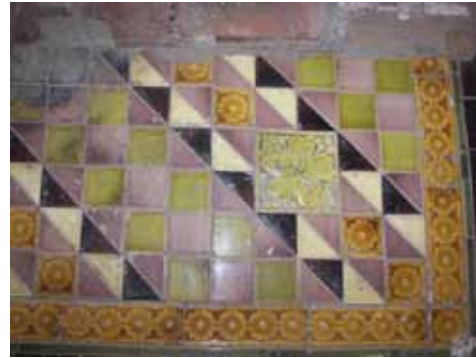
Hearth detail.
2011
